## Visual Building Inspection Report

**Property Inspected: 2 Sample St SAMPLE**

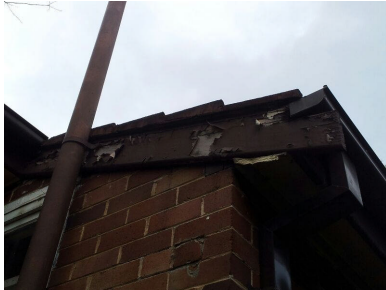
#### *Fascias & Bargeboards Type & Condition*

The overall condition of the fascias/bargeboards is poor. Severe wet rot decay is present to timber fascias or barge boards. Some replacement is required. The paint work is deteriorating and maintenance is required. Water damage/staining is present.

**Estimated Cost: \$ 1800,00.**

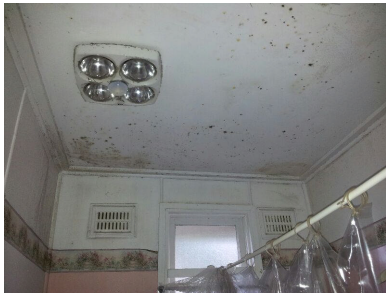
#### Bathroom One

Rear, Recommend full renovation.

**Estimated Cost: \$ 6800,00.**

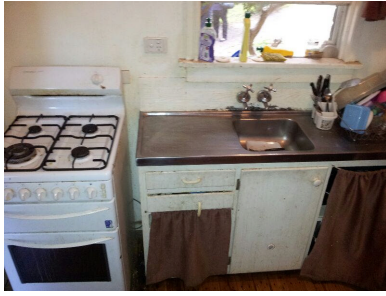
#### Kitchen

The condition of the fixtures is generally poor. Wet rot decay is present to cupboards. Wet rot decay is present to the bench top. Recommend full kitchen replacement.

**Estimated Cost: \$ 10 800,00.**

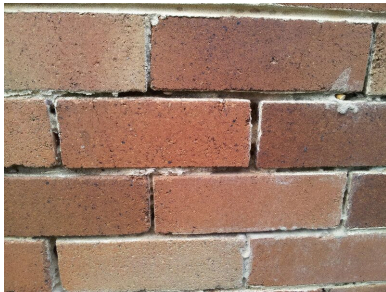
### Walls

The condition of the walls is generally poor. The mortar joints between brickwork is deteriorating and needs re pointing.

**Estimated Cost: \$ 1800,00.**

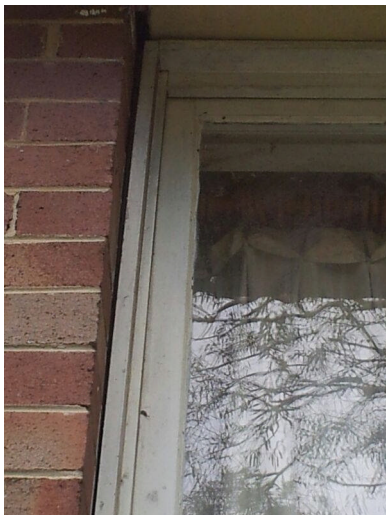
### Windows

The condition of the exterior of the windows is generally poor. Putty in windows has deteriorated and requires attention. Moderate wet rot decay is present to window frames. Maintenance will be required.

**Estimated Cost: \$5 800,00.**

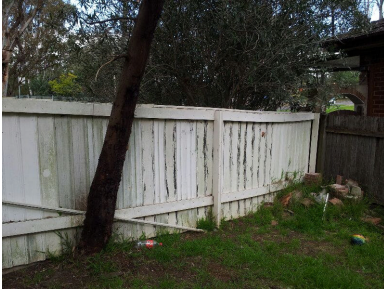
### Fences & Gates

The fences are mainly constructed from timber and metal. The fences are generally in poor condition and repairs or replacement is required. Major wet rot or defects were noted to the wooden fences and major repairs are needed.

**Estimated Cost: \$ 2800,00.**

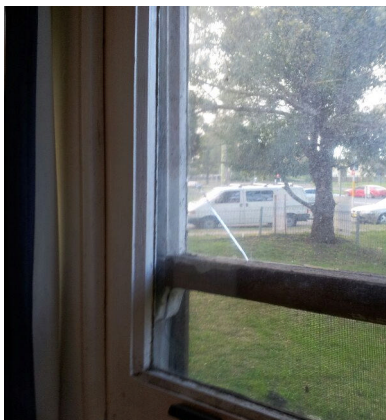
##### *Windows Condition*

The condition of the windows is generally poor. Crack to glass panels.

**Estimated Cost: \$ 300,00.**

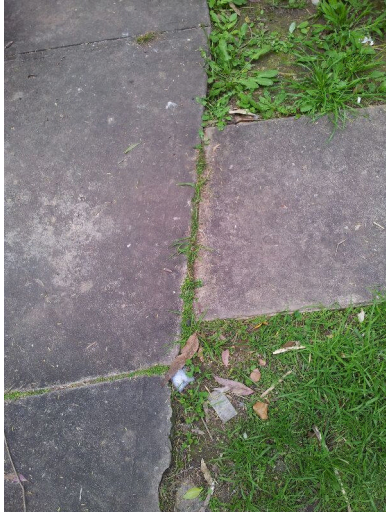
The concrete paths have subsided in areas and will require repair.

**Estimated Cost: \$ 1800,00.**

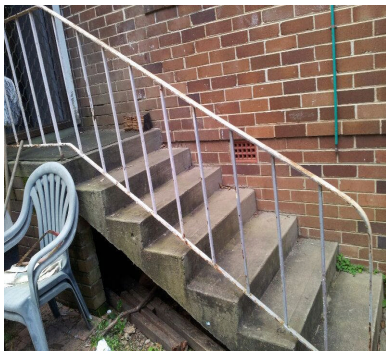
External Stairs

The stairs are constructed primarily from concrete. The overall condition of the stairs is fair. Movement is evident to the railing. This will require maintenance/repair.

**Estimated Cost: \$ 800,00.**

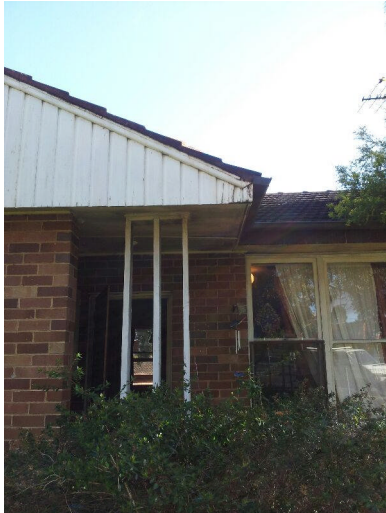
Verandah

*Defects or Maintenance Items*  
support posts deflection.

**Estimated Cost: \$ 1300,00.**

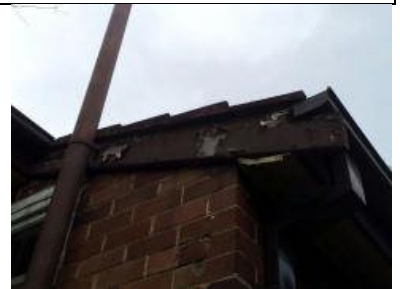
**Fascias & Bargeboards Type & Condition**

The overall condition of the fascias/bargeboards is poor. Severe wet rot decay is present to timber fascias or barge boards. Some replacement is required. The paint work is deteriorating and maintenance is required. Water damage/staining is present.

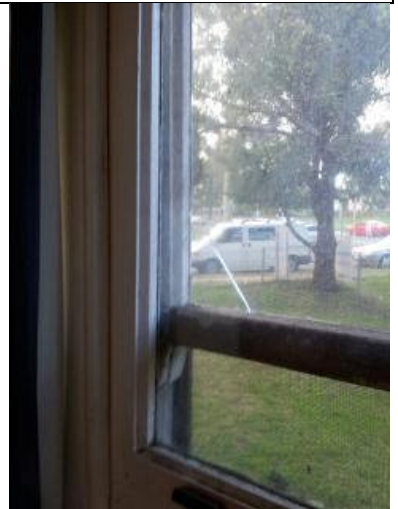
**Windows Condition**

The condition of the windows is generally poor. Crack to glass panels.

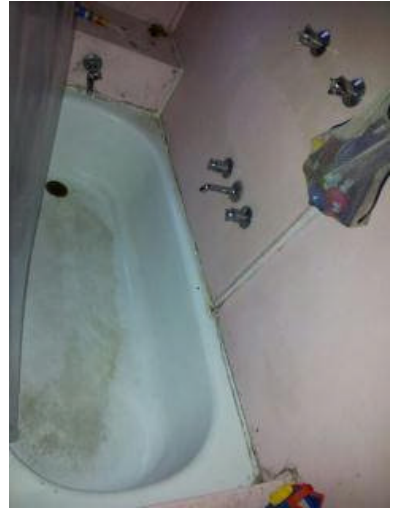
**Shower/Bath Condition**

The shower is located over the bathtub. Water penetration from this shower is occurring and suitable waterproofing methods should be used.

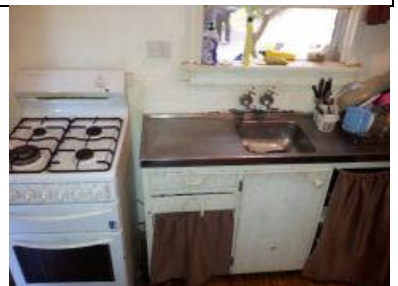
**Kitchen Fixtures**

The condition of the fixtures is generally poor. Wet rot decay is present to cupboards. Wet rot decay is present to the bench top. Recommend full kitchen replacement.

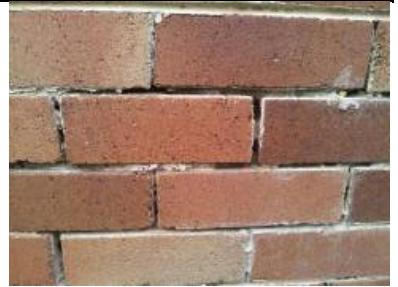
The condition of the walls is generally poor. The mortar joints between brickwork is deteriorating and needs re pointing.

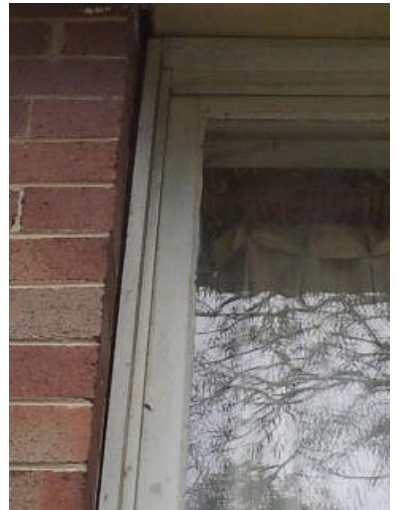
The condition of the exterior of the windows is generally poor. Putty in windows has deteriorated and requires attention. Moderate wet rot decay is present to window frames. Maintenance will be required.

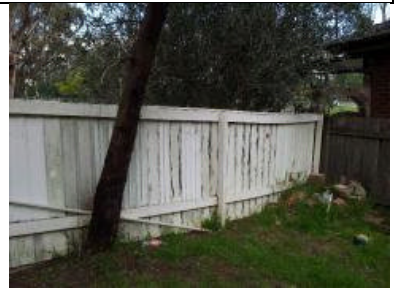
### Fences Type & Condition:

The fences are mainly constructed from timber and metal. The fences are generally in poor condition and repairs or replacement is required. Major wet rot or defects were noted to the wooden fences and major repairs are needed.

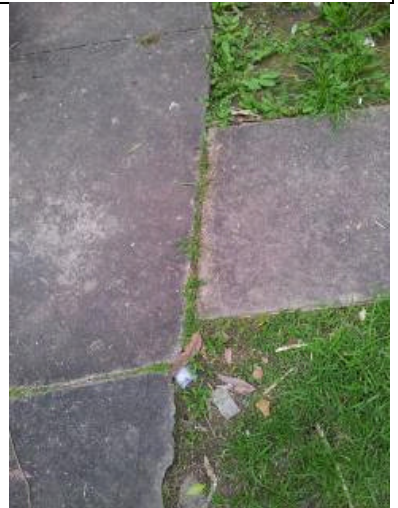
The concrete paths have subsided in areas and will require repair.

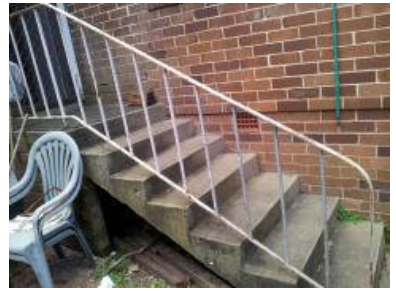
## External Stairs

The stairs are constructed primarily from concrete. The overall condition of the stairs is fair. Movement is evident to the railing. This will require maintenance/repair.

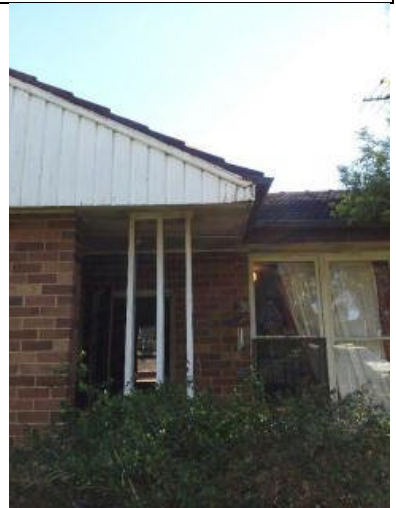
support posts deflection.

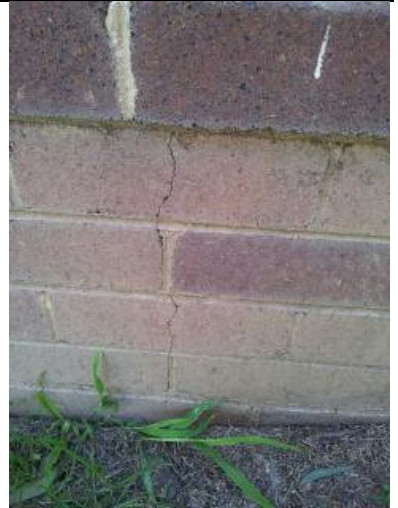
The building is constructed on a combination of strip footings and piers. Evidence of minor subsidence was noted to the footings. This should be monitored over time and any increase referred to a Structural Engineer. 1.
