Visual Timber Pest Inspection Report

Property Inspected: 2 Sample St SAMPLE

VCS-12-1013P.

31/07/2011.

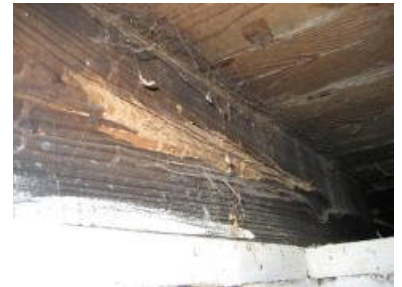
Active Subterranean Termites Found

Yes - Inspection revealed currently active termites within this area including but not necessarily limited to the following timbers and the areas listed below.

Coptotermes spp.

Bearers: Floor joist/s:

recommended, see Section 3.0 - Further Invasive Inspection. The species of termites found active and their potential to cause damage are detailed below. *Coptotermes* spp. are considered to be a significant structural pest of timber and are capable of causing significant structural damage to timbers. They are one of the most economically damaging termite species and a termite management program is essential where this termite species has been found.

Due to comments made in this report regarding timber damage, the fact that we are not builders and are not qualified to assess the extent of damage to timbers, we recommend that a builder inspect the timber damage and give a qualified opinion regarding same.

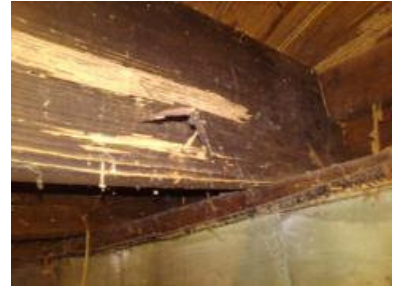
Main bathroom:

Visible timber damage appears moderate to severe however, we are not builders and this is not to be considered a builder's opinion. Refer to the definitions section of this report - Section 1.6 - Timber Damage.

The underfloor soil appears damp. This should be monitored on a regular basis as moist soil conditions are highly conducive to timber pest attack. Poor drainage, especially in the subfloor, greatly increases the likelihood of wood decay and termite attack. We claim no expertise in plumbing and drainage, however it may be that the drainage is inadequate and in need of improvement.

Underfloor ventilation is inadequate. Active decay fungi is present on the underfloor timbers and the immediate improvement in ventilation is required. Due to the method of construction, we recommend forced fan ventilation be installed.
