Visual Timber Pest Inspection Report

Property Inspected: 2 Sample St SAMPLE

VCS-12-1013P.

31/07/2011.

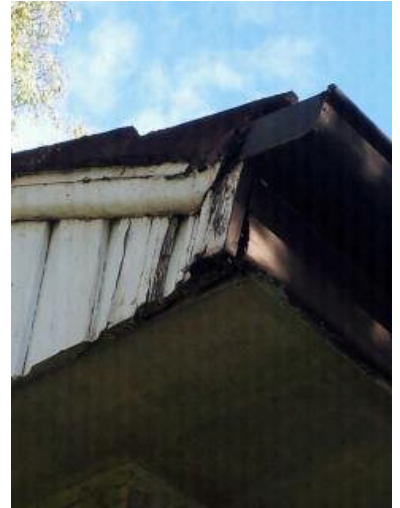
Active (live specimens) Termites (White ants) were found. Please read the entire report.

Visible evidence of termite damage such as mud tubes or damaged timbers were found. You may need to arrange for a treatment and may need to consult a builder or other expert. Please read the entire report.

Evidence of damage resulting from wood decay fungi (wood rot) was found. Please read the entire report.
